EVAPORATOR ASSEMBLY REAR

1. (a) **Nomenclature:** Evaporator Assembly Rear
(b) **Part No.:** PC90254-01(MEGGIT ADDISON), 9599001112
(c) **GIG No.:**1539719
2. **Year of Procurement/ Source:** (AHQ/3101) Pilatus Aircraft Ltd
3. **Fleet/ Sub System/ Wpn System:** Pilatus
4. **Technical Applicability/ Broad Purpose:** To develop in-house ROH facility in the absence of MToT.
5. **Technical Specifications (attach as separate sheets):** FIG 01 ITEM 90 CHAP-21-50-02 OF IPC PC-7 MK II
6. **Publication Details (attach as separate sheets):** IPC CHAPTER 21-50-02 FIG-0
7. **Photograph of Equipment**

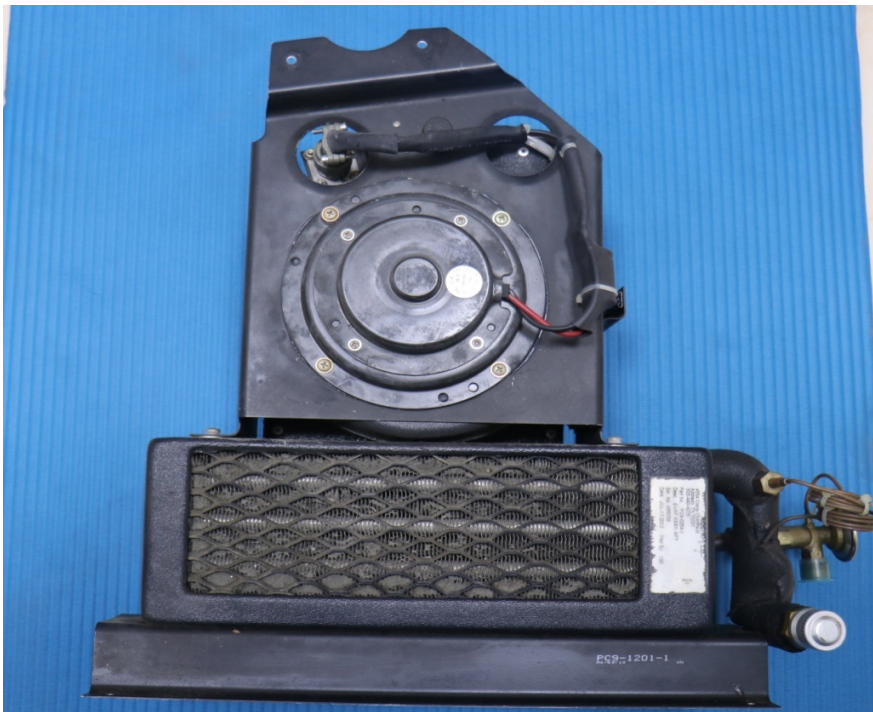
EVAPORATOR ASSY REAR
P/N PC9-0254-1

8. Brief Description: There are two evaporators in the system. Rear Evaporator is installed on the floor of rear cockpit, under the rear instrument panel. The unit comprise:

- (a) A core heat exchanger
- (b) A two-speed blower fan mounted in a thermoplastic housing
- (c) An expansion valve.

The expansion valve automatically adjusts the flow of refrigerant through the evaporator to prevent the formation of ice, which could block the evaporator matrix. The blower fan unit circulates air through the heat exchanger, which extracts the heat from the air flow. The cooled air is then directed through the air distribution unit to the air outlets.

A water drain on the evaporator passes overboard any condensation which forms.
