## **BDPI-09 (Primary Information Sensor Unit)**

1. Nomenclature/ Part No/ GIG No. - **BDPI-09 / Primary Information Sensor Unit / 1441532**

3. Fleet/ Sub System/Wpn System. –**Mi-17V5 / BDPI-09**

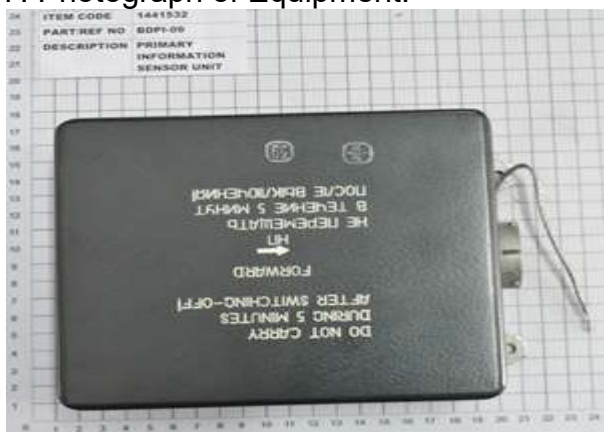
7. Photograph of Equipment.

8. Brief Description. IT MEASURE ANGULAR RATES AND LINEAR ACCELERATION ACTING ABOUT ITS MEASURING AXIS, PERPENDICULAR AXES

The PISU incorporates three rate gyros (measurement range of angular rates about the X and Z axes 30°/s, about the Y axis 60°/s) and three solid-state accelerometers (measurement range of linear accelerations in the X and Z axes is  $\pm 3$  g, in the Y axis is  $\pm 5$  g) housed in a single enclosure. The PISU consists of two DUSU-M-30AC rate gyros, one DUSU-M-60AC rate gyro, two AT-1112-3B accelerometers, one AT-1112-5B accelerometer and a MDM-15 built-in power supply.
